Can We Fix It?

An in-depth look at cusp replacement using composite, pins and polyethylene fibers

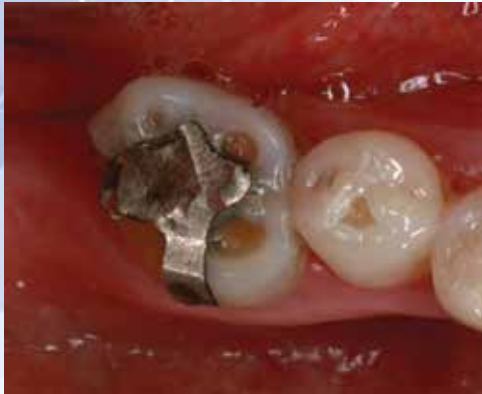
Fig. 1: A patient presents with a large amalgam Class II failure in the mandibular first molar with a fractured distobuccal cusp. While an onlay or crown is probably the restoration of choice, a direct resin was chosen because of the patient's time constraints.

A 62-year-old patient in good general health presented with sensitivity in the right side of his mouth. The clinical exam revealed a mandibular right first molar with an extensive amalgam fracture and a missing distobuccal cusp (Fig. 1). The procedure was performed with a rubber dam to achieve total isolation. This technique is essential²⁹ and no other isolation method provides better control over oral fluids and moisture contamination.³⁰

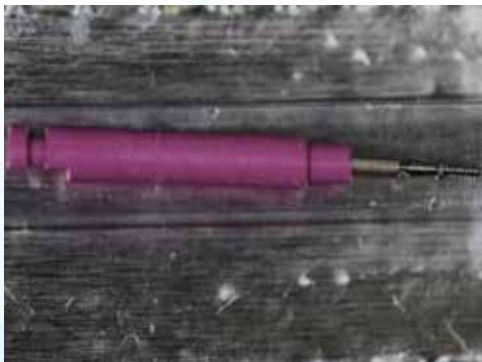
Fig. 2: The one-time-use Max pin latch type came in a sealed plastic container. Place the pin into a low-speed handpiece.

After completing the preparation of all internal angles, they must be rounded to reduce stress concentration³¹ and improve the adaptation of composite resin to the dental structure. No bevels were placed on the occlusal or gingival margins. It is suggested to use one pin per missing cusp³²; in this case, only one was needed. Displaying enough room from the base to the cusp tip (4mm) is crucial for the placement of the pin. Sufficient dentin is necessary to attain adequate strength to avoid external fractures of the tooth structure and to protect the pulp. Once the channel location is decided, a pinhole guide is formed with a ¼-round bur (slow speed) in dentin, 1.5mm on the external surface. The Max 021 system of pins from Coltene/Whaledent (Fig. 2) was used in this case.

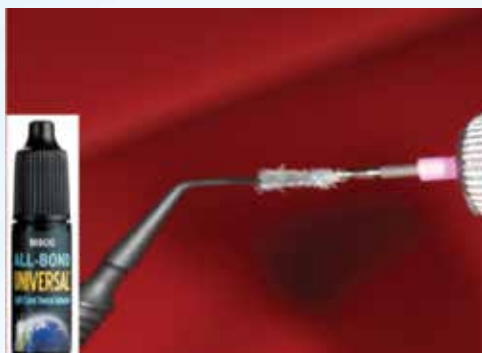
Fig. 3: All-Bond Universal primer from Bisco (10 micros) is applied to the Max pin.

Using a pilot drill, with a slow-speed contra angle, a pinhole was prepared until the drill shoulder came to a stop. The channel preparation was done to full depth and a pin was inserted into the handpiece and covered with primer adhesive from Bisco (Fig. 3) while operating at very low speed with light pressure until the pin sheared and the placement was completed (Fig. 4).

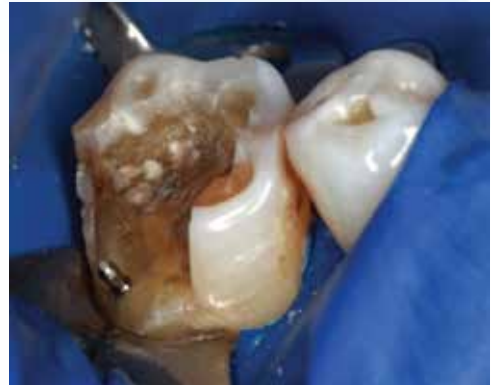
Fig. 4: Rubber dam has been positioned after the amalgam was removed. (Note the access to the gingival extent of the fractured cusp.) During the pin placement, use a very low speed and slight pressure downward until the pin shears. This means the pin placement has been completed.

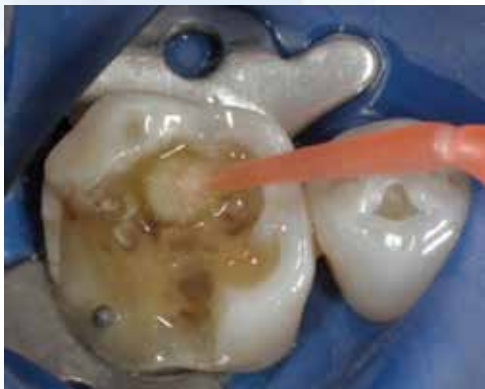
Fig. 6: After applying an antibacterial solution, a generous amount of primer is scrubbed for thorough penetration onto the surfaces.

Every surface is microetched with 35 microns aluminum oxide (Crystal Air by Crystalmark Dental Systems). Two percent chlorhexidine (Cavity Cleanser by Bisco) was used to disinfect the preparation and it was then dried with light air. A selective-etch technique was chosen and phosphoric acid (Select HV Etch by Bisco) was applied on the enamel for 15 seconds (Fig. 5, p. 86), then rinsed thoroughly and dried. Then, OptiBond XTR primer (Kerr) was applied by scrubbing with moderate pressure for 30 seconds (Fig. 6, p. 86). The adhesive from OptiBond XTR was used with gentle agitation for 15 seconds (Fig. 7, p. 86), followed by a warm air dry to thin out the layer and evaporate the solvent.

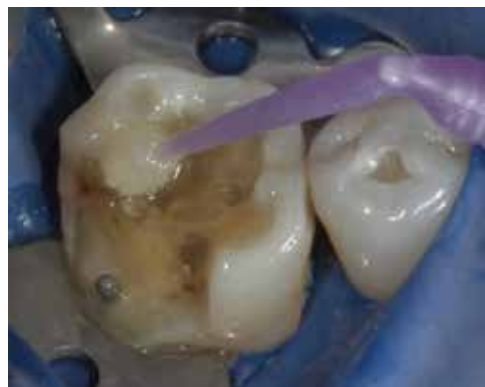
Fig. 7: Once the primer has evaporated with the assistance of slight warm air, the bonding agent is applied and thinned out.

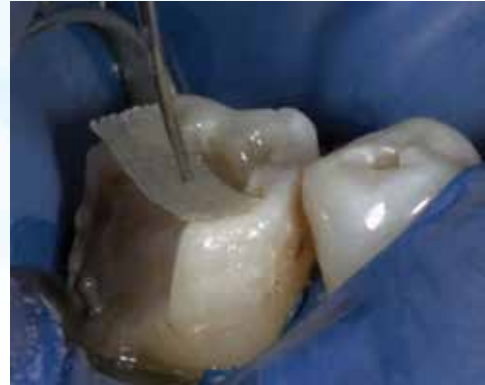
Fig. 8: An application of a thin layer of composite tacky flowable is placed. Then an end of an endodontic plugger was used to pick up the polyethylene fibers (Ribbond) soaked in unfilled resin to enable their transfer to the preparation. The fibers are placed and pushed closest to the dentin floor and extended slightly up the axial and proximal walls.

A thin 0.5mm layer of tacky thickened flowable composite (Ribbond Securing Composite) was placed onto the pulpal floor, which is of high opacity. The high-strength polyethylene fibers, by Ribbond (Fig. 8), were blotted with an unfilled bonding adhesive and the excess was removed with lint-free gauze. The polyethylene fibers were adapted and pressed as close to the pulpal floor as possible (Fig. 9), then light-cured.

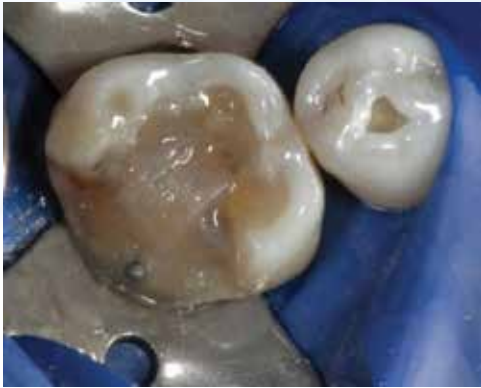
Fig. 10: After application of polyethylene fibers, adapted closely, without suffering pullback. In the end they disappear into the composite. These fibers can increase the fracture toughness of the tooth and prevent dentin crack propagation.

In one study, it was found when fibers were inserted into the depth of the proximal box, little or no microleakage took place³³ and increased the microtensile bond strength to the dentin in cavities with a high C factor.³⁴ Another thin layer of composite was applied (Fig. 10) and the final buildup was done with a warmed filled restorative composite to increase durability.³⁵ Tints (Kolor Plus by Kerr) were placed to create the anatomy and glycerin was placed on every surface (Fig. 11) and light-cured for 40 seconds on each side.

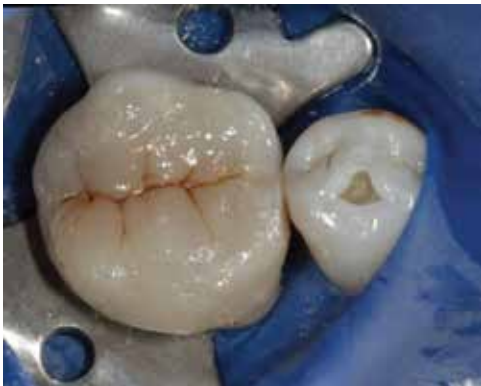
Fig. 11: After an enamel composite layer is placed, the anatomy is created. Glycerin is applied to all margins to prevent the formation of an air-inhibited layer. The restoration is light-cured on the facial, lingual and occlusal sides.

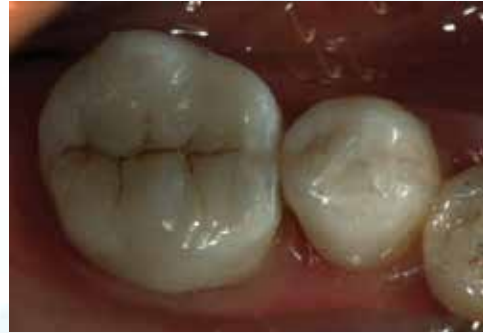
Fig. 12: After removing the rubber dam, the occlusion is evaluated in every movement. The restoration is now contoured.

The rubber dam was removed, and the occlusion was inspected in all eccentric movements to avoid any premature contact (Fig. 12). The restoration was contoured and began spreading with intraoral polishing paste (DiaShine by VH Technologies) using a latch brush and keeping light in constant contact with the restoration (Fig. 13), to provide a higher surface luster (Fig. 14). As a preventive measure for occasional bruxism, the patient was provided a night guard.³⁶

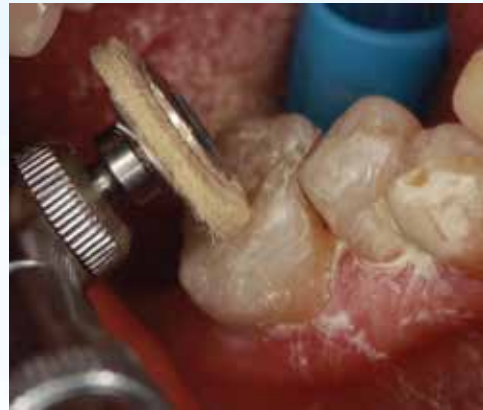
Fig. 13: A few weeks later, the patient came for examination. Intraoral polishing paste (DiaShine by VH Technologies) was used with a latch brush and kept continual contact with the restoration to provide a great surface finish.

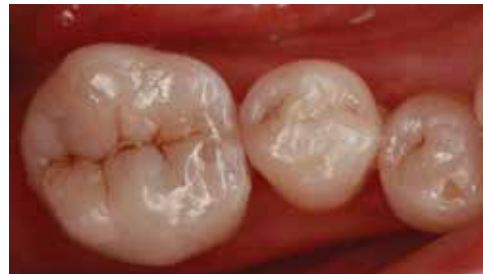
Fig. 14: Note the excellent anatomical form and pleasing high surface luster.
